This errata sheet provides information about known device issues affecting Arria® V production devices.

Device Errata for Arria V Production Devices

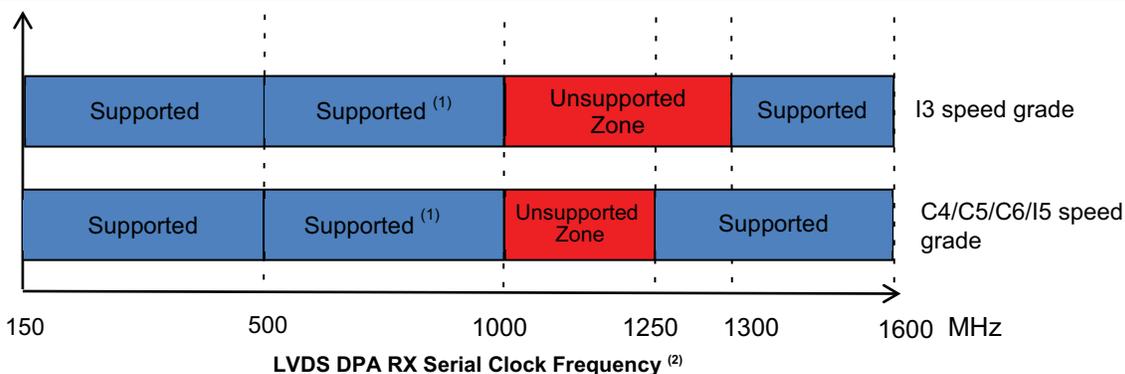
Figure 2. Arria V GX/GT LVDS DPA RX Supported and Unsupported Data Rates

DPA mode or soft-CDR mode is not supported for specific LVDS data rate as shown in [Figure 2](#). If the RX channels with DPA are operating in the unsupported zone, bit errors may occur. This limited LVDS data rate support impacts early die revision Arria V GX/GT device when LVDS receiver channels operating in DPA mode or soft-CDR mode. LVDS receiver channels operating in non-DPA are not affected. The unsupported data rate zones are dependent on device speed grade as shown in [Figure 2](#). The affected Arria V GX/GT die revisions are shown in [Table 7](#).

- (1) Supported with recompilation in Quartus II version 13.0 and later. Not supported in Quartus II version 12.1SP1 and earlier. If the RX channels with DPA are operating in this zone with Quartus II version 12.1SP1 and earlier, bit errors may occur.
- (2) The scale of the LVDS DPA RX serial clock frequency is for illustration purposes only.

For the LVDS data rate solutions in the unsupported zones, refer to [Table 5](#) and [Table 6](#).
