AM1806 ARM Microprocessor Silicon Revisions 2.3, 2.1 and 2.0

Silicon Errata

Literature Number: SPRZ314H
March 2010–Revised September 2014

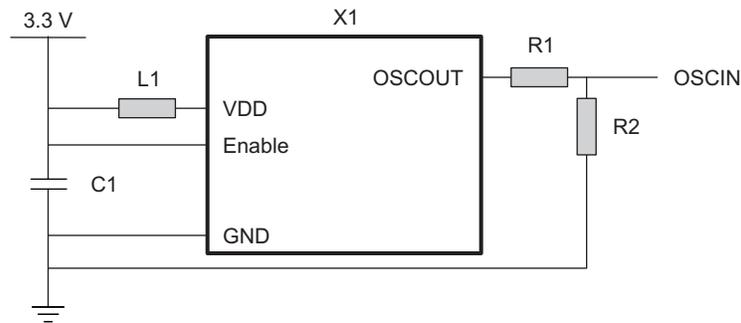
Figure 2. External 3.3V Clock Source

On all silicon revisions, certain design elements make this device susceptible to radiated noise during an ESD strike, as described in the standard IEC 61000-4-2. Exposure to the electrical noise caused by the ESD can cause soft device failures due to noise coupling on the system clock (OSCIN). ESD events within the IEC spec range do not cause permanent device damage and full functionality is recoverable with a device reset. The sensitivity to this noise issue is primarily due to the 1.2V oscillator/clock input implemented on this device. The low voltage range, coupled with slow rise and fall times, provides a lower noise margin than other TI devices with higher voltage internal oscillators (for example, 1.8V or 3.3V oscillators).

If ESD robustness is a concern, it is strongly recommended to avoid using the internal oscillator as a clock source. An external 3.3V clock source with a resistor voltage divider as in [Figure 2](#) can be used to externally generate the required 1.2V input clock. By using an external clock input with fast rise/fall times (less than 5 ns), the noise margin improves significantly, increasing ESD noise resistance.

A Legend: L1 = ferrite bead; C1 = 0.1 uF; R1 = 165 ohm / 5%; R2 = 100 ohm / 5%

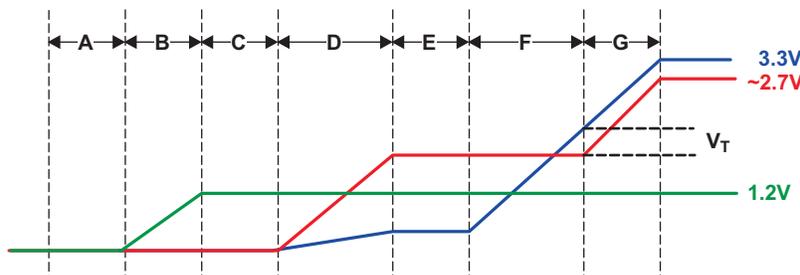
Figure 4. Faulty power-supply ramp

The behavior is the same until zone G. When the DVDD3318_x supply exceeds DVDD18 by a transistor V_T , the DVDD18 supply begins to be pulled up by the DVDD3318_x supply and follows the DVDD3318_x supply by $DVDD3318_x - V_T$. Since the DVDD18 supply is often connected to other 1.8V supplies in the design, these other supplies can be pulled up also.

The condition occurs because the dual-voltage IO buffers have voltage detection circuitry that monitors DVDD3318_x during reset and determines whether the applied supply voltage is 1.8V or 3.3V. This detection circuitry then configures the IOs to operate at the appropriate voltage. As the DVDD3318_x supply ramps, there is a small range near DVDD18 + V_T where the voltage detection circuit finds the state indeterminate and briefly turns on circuitry associated with both voltage options creating a current path between them. This current path can cause the DVDD18 supply to be pulled up. The mechanism for this behavior is explained below:

1. Design simulation has indicated that under the worst-case process/voltage/temperature conditions the maximum leakage current into the DVDD18 supply due to this phenomenon will be 140 mA (the 140 mA is a cumulative current generated by all of the dual-voltage IOs). So this error state can be prevented by ensuring that the load on the DVDD18 supply during the DVDD13318_x supply ramp exceeds 140 mA. This can be achieved by any combination of the following as long as they cumulatively produce >140 mA load on DVDD18 during the DVDD3318_x ramp period:

- (a) Maintain sufficient bulk capacitance on the DVDD18 supply such that the charging current for these capacitors provides all or part of the required >140 mA. Bulk capacitance in this context means the total capacitance seen by the DVDD18 supply (filter capacitors, bypass capacitors, etc.). Capacitor charging current is defined as $I = C \cdot (dV/dt)$. So the ramp rate of the DVDD3318_x supply and the total bulk capacitance on the DVDD18 supply can be used to calculate the current produced. This solution provides additional power supply filtering and little current leakage after the supplies are ramped (depending on the type of capacitors used). The table below shows some examples of the bulk capacitance that would be required to use this solution alone:

2. Choose a regulator for the DVDD18 supply (or grouped 1.8V supplies) that is capable of actively regulating voltage up and down. Many high-efficiency switching regulators switch current into the load only when the voltage needs to be raised and rely on the load to pulldown the current. In this error condition, a regulator of this type will not be able to compensate for the leakage current described above. Synchronous buck regulators use external inductance to pulldown the regulated voltage when necessary.

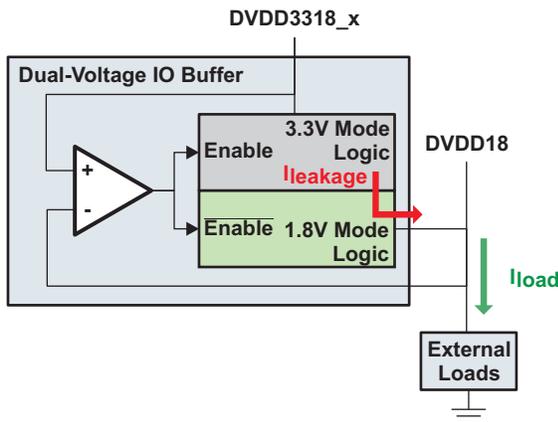
Figure 6. Error State of the IO buffer during Zone G

Error State of the IO buffer during Zone G:

As DVDD3318_x exceeds DVDD18+V_T, some of the circuitry across the boundary of the two voltage domains will turn on and causes a leakage current (in red) to flow between the two voltage domains. This current pulls up the DVDD18 supply unless the power source providing that supply can oppose it or unless the load current is strong enough to counteract it.

If DVDD18 continues to rise as DVDD3318_x ramps, the comparator never sees enough difference between the two supplies to switch to 3.3V mode.

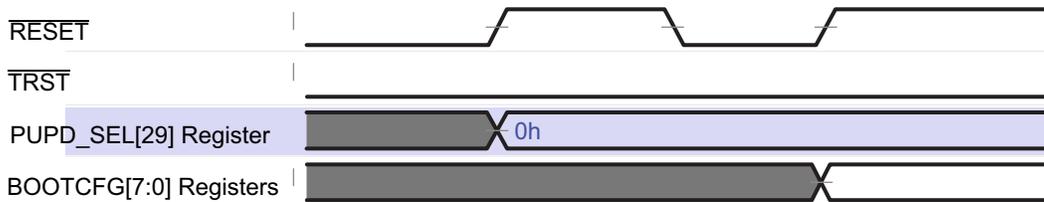
Initialization of PUPD_SEL[29] and BOOTCFG[7:0] Registers with Weak or No External Pull Resistors on BOOT[7:0] Pins

Internal pullups being enabled on the BOOT[7:0] pins may result in boot failures. If weak external pulldown resistors are used on the PCB to select the boot mode, they may not be able to overpower the internal pullups. This can result in the wrong boot mode being latched in the BOOTCFG[7:0] register when coming out of Reset.

Once the device is out of Reset, the PUPD_SEL[29] register is initialized, and the internal pulldown resistors for the BOOT[7:0] pins are all enabled. Issuing a second Power-On Reset (\overline{POR}) results in the intended boot mode being latched, since the pins are internally pulled down as expected.

[Initialization of PUPD_SEL\[29\] and BOOTCFG\[7:0\] Registers with Weak or No External Pull Resistors on BOOT\[7:0\] Pins](#) shows the behavior of the PUPD_SEL[29] register before and after reset. Assuming weak or no external pull resistors are on the BOOT[7:0] pins, the BOOTCFG register will latch the unknown values after the device initially comes out of Reset. Note that, \overline{TRST} *must* always be low in order to issue a \overline{POR} and latch the boot pin values -- the boot pins are not latched after a Warm Reset.

Section 4, *Device Operating Conditions*, of the device datasheet shows the electrical characteristics information which can be used to calculate the maximum external pull resistance required. The value is dependent on the DVDD3318_C I/O supply level.

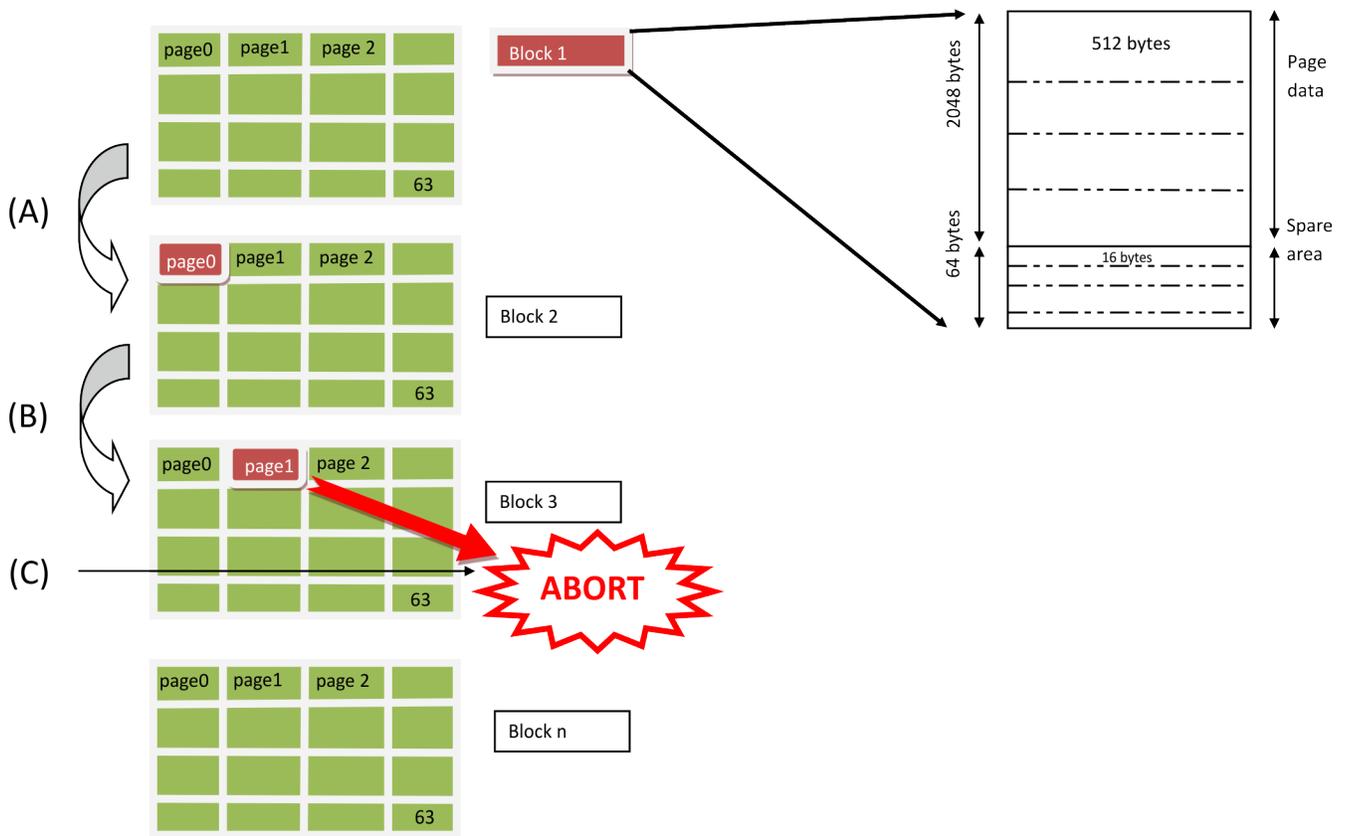
D800K008 ROM Behavior Before Application of Software Patch⁽¹⁾

However, over the life span of the NAND flash, ECC data stored in the spare area can develop errors due to bit flips. When the calculated syndrome indicates an error in the ECC data, the ECC Correct and Read functions of the RBL abort the read process even though, it is possible to correct up to 4 bit errors combined in user and ECC data. Consequently the device fails to boot.

If page0 of the good block has an ECC data error or an uncorrectable error (more than 4 bit errors combined), the RBL skips to the next block (shown as (B) in [D800K008 ROM Behavior Before Application of Software Patch^{\(1\)}](#)). This bad block check mechanism enables the device to check up to the first 32 blocks in the NAND flash for booting (the boot process will fail if all 32 blocks have uncorrectable or ECC data errors in page0). Note that the RBL does not abort on detecting an error in ECC data on page0.

Once the RBL finds a good block with a good page0, it continues to read subsequent pages in that block. If an uncorrectable or ECC error is detected in subsequent pages, the RBL will abort with a boot error (shown as (C) in [D800K008 ROM Behavior Before Application of Software Patch^{\(1\)}](#)). The workaround, described below, enables the boot process to continue for both types of errors (ECC data and uncorrectable errors).

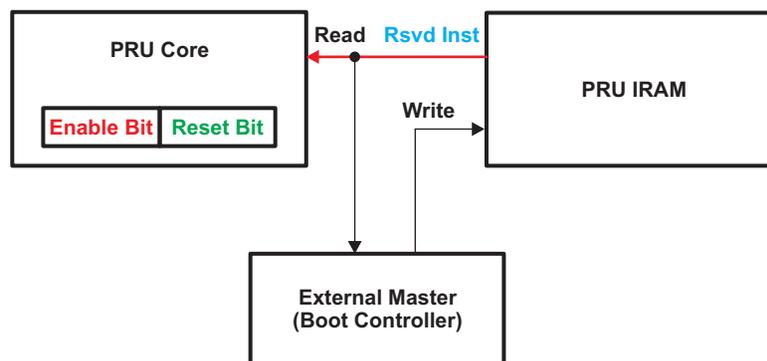
Figure 9. Boot Failure on Power-On

When the device is first powered-on, the read bus from the PRU IRAM is not initialized and will contain random values (see Figure 9). Under unpredictable circumstances, the random value on the read bus may resemble a reserved instruction which can be interpreted by the PRU when the core is reset and not enabled.

If the PRU core executes this reserved instruction, it will not be able to properly execute the first functional op-code in the PRU IRAM when the core is later enabled. In this fail state, the PRU will never acknowledge to the Boot Controller that the reset vector table was successfully initialized and the Boot Controller will be stuck in a polling loop waiting for the PRU to complete its task.

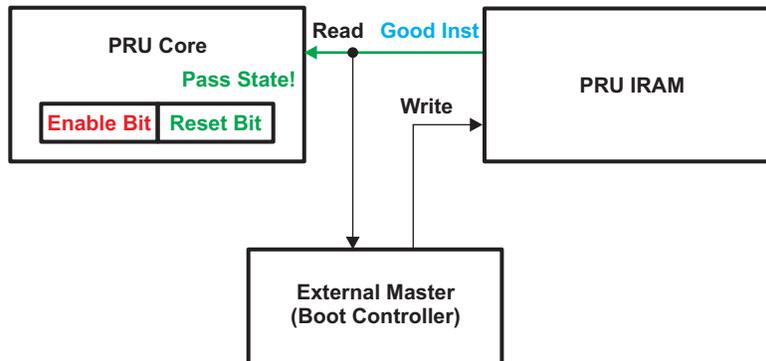
Figure 10. Secondary Reset

Although the PRU core execution is stuck, the PRU IRAM read bus is now initialized with a non-reserved instruction that was fetched from the IRAM by the PRU core (see Figure 10). If a secondary reset is provided to the device (either POR or WARM), the PRU will be able to execute its functional instructions as expected.

Note that in order to recover from this fail state with a secondary reset, the Boot Controller must be allowed to execute up to the point where the PRU has fetched a known instruction from the PRU IRAM. The approximate count of 15k clock cycles is sufficient.
