**TMS320C6672**  
**Multicore Fixed and Floating-Point Digital**  
**Signal Processor**  
**Silicon Revision 1.0, 2.0**

**Silicon Errata**

Literature Number: SPRZ335H  
January 2011–Revised June 2015

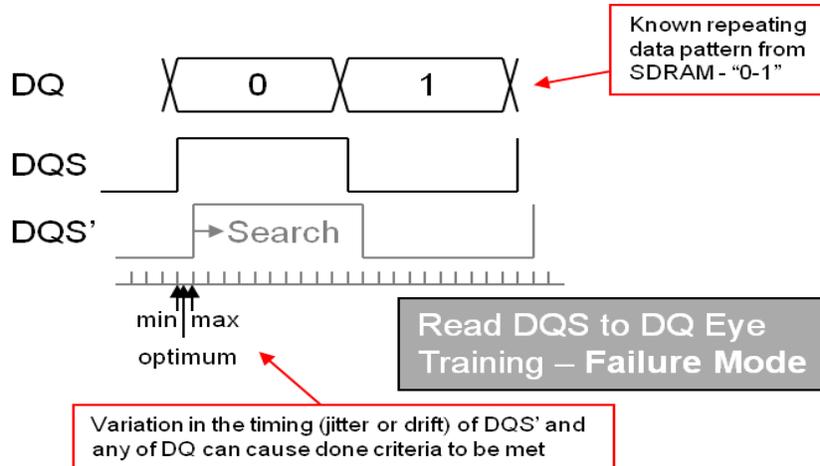
Figure 4. Read DQS to DQ Eye Training - Failure Mode

The leveling feature with the problem is the Read Data Eye Training. Depending on the jitter seen on the DQ and DQS signals, this leveling feature will fail to converge on a good data eye, resulting in corrupted DSP to DDR3 SDRAM reads.

However, if too much jitter is present on the DQ or DQS signals, the search can converge to a false edge as shown in Figure 4.

**Workaround 1:**

This mode is enabled by setting bit 9 (0-indexed) of the DDR3\_CONFIG\_REG\_23 at address 0x02620460. The lower 8 bits (bits 7:0) must not be overwritten and will contain their default value of 0x34. The default value is recommended for use. After programming DDR3\_CONFIG\_REG\_23, proceed to enable auto-leveling. Please refer to the *DDR3 Initialization Application Report* ([SPRABL2](#)) for details of the sequence of steps.

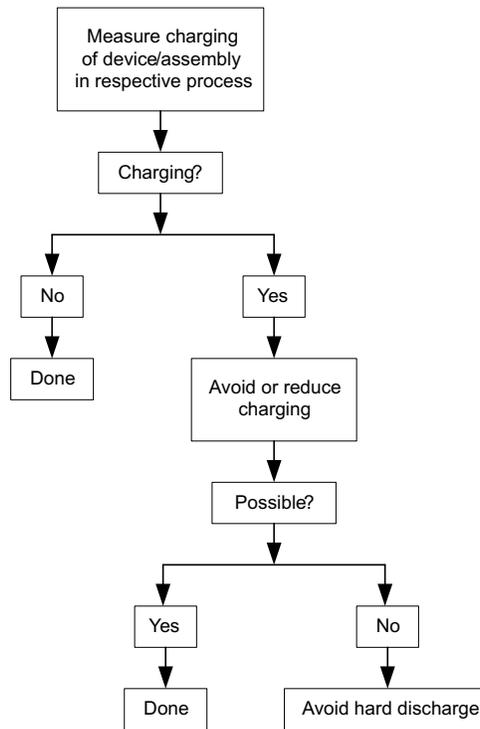
**Figure 6. The Basic Flow to Analyzing the Risk**

**Details:**                    All data manual specifications associated with the SerDes high-speed functional pins are guaranteed to a maximum component Electrostatic Discharge - Charged Device Model (ESD-CDM) pulse threshold of 150V.

Due to the sensitive nature of the SerDes high-speed pins, exceeding component ESD CDM stress pulses of 150V on the functional pins listed below may cause permanent changes to the output swing and the de-emphasis behavior associated with these pins.

**Workaround:**                While there is no strict workaround for this issue, there are several ways to analyze the risk with regards to CDM. [Figure 6](#) shows the basic flow for analyzing this risk:

Using generally accepted *good practices* during the assembly process can help to minimize the likelihood of a hard discharge. These practices include:

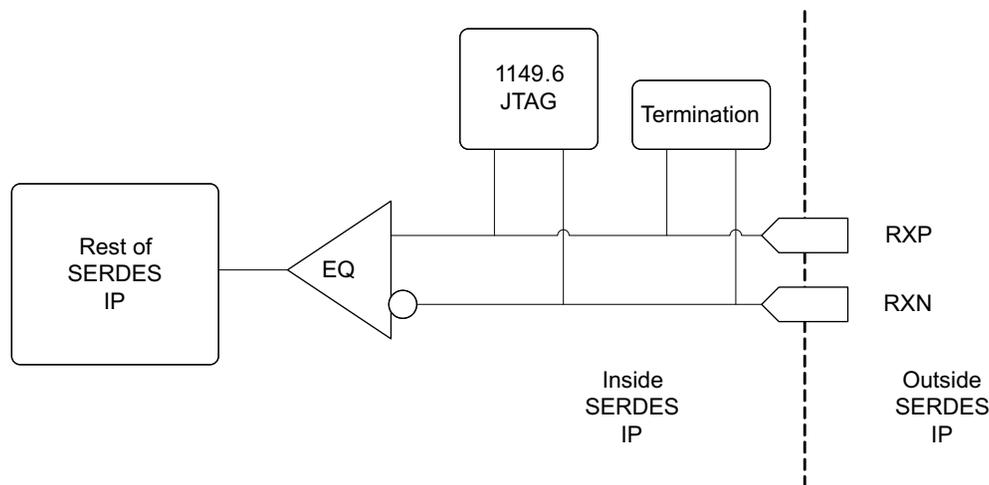
**Figure 7. Simplified SerDes Receiver Block Diagram Depicting Relative Placement of Major Receiver Components**

The SerDes receivers as shown in Figure 7 for AIF2, SRIO, PCIe, SGMII and Hyperlink are all designed to be AC coupled to their associated transmitters. For these AC-coupled SerDes receivers the IEEE 1149.6 scan-chain provides edge-sensitive sensing.

A problem has been identified in some cases where the AC-JTAG (IEEE 1149.6, edge-sensitive) input cells on Rincewind and Draco receivers do not reliably respond to input edge transitions from an associated transmitter. Because of this failure, the 1149.6 scan-chain users can receive faulty signal levels transitions or no transitions at all.

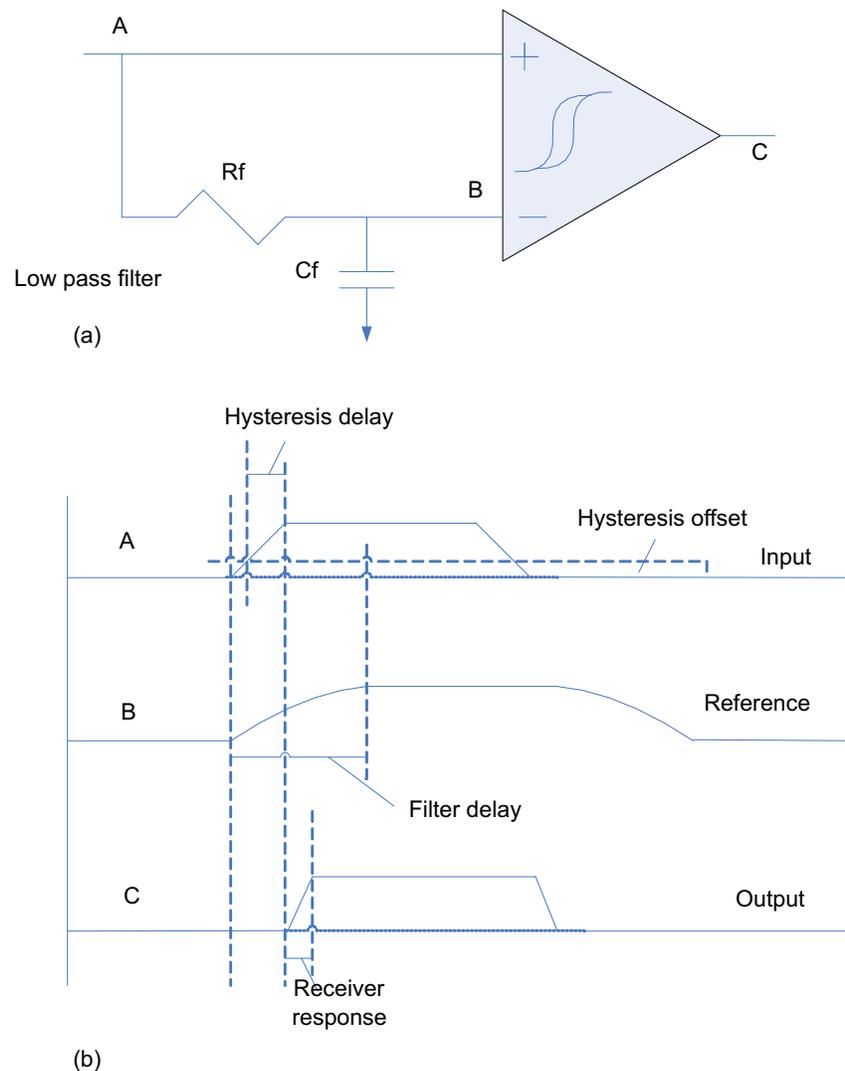
**Figure 8. Self-referenced Comparator and Response**

The AC-JTAG input cell is based on a self-referenced, hysteretic comparator. See Figure 8. If the SerDes receiver pins are idle (no transitions are applied), the voltage of the pins will settle to the programmed, receiver common-mode voltage (0.80V nominally). From this idle state a single edge transition applied to the AC-JTAG input cell can push both terminals of the AC-JTAG comparator inputs past the VDDT (1.0V) supply voltage level.

When the comparator inputs are saturated the comparator gain is minimized and under certain PVT conditions (strong silicon, 125C junction temperature, minimum VDDT), the comparator can fail to switch to the proper state, or not respond at all.

One potential workaround has been identified. The failure mode of the AC-JTAG comparator is most pronounced by single edge transitions at low frequency as this creates the highest likelihood of the comparator inputs being saturated and switching incorrectly. More frequent transitions can result in proper switching of the comparator output.

The basic procedure is to initiate multiple edge transitions and then read the state of the RX input cell in question. However, due to the nature of the failure, the exact number would have to be determined experimentally for a given device.

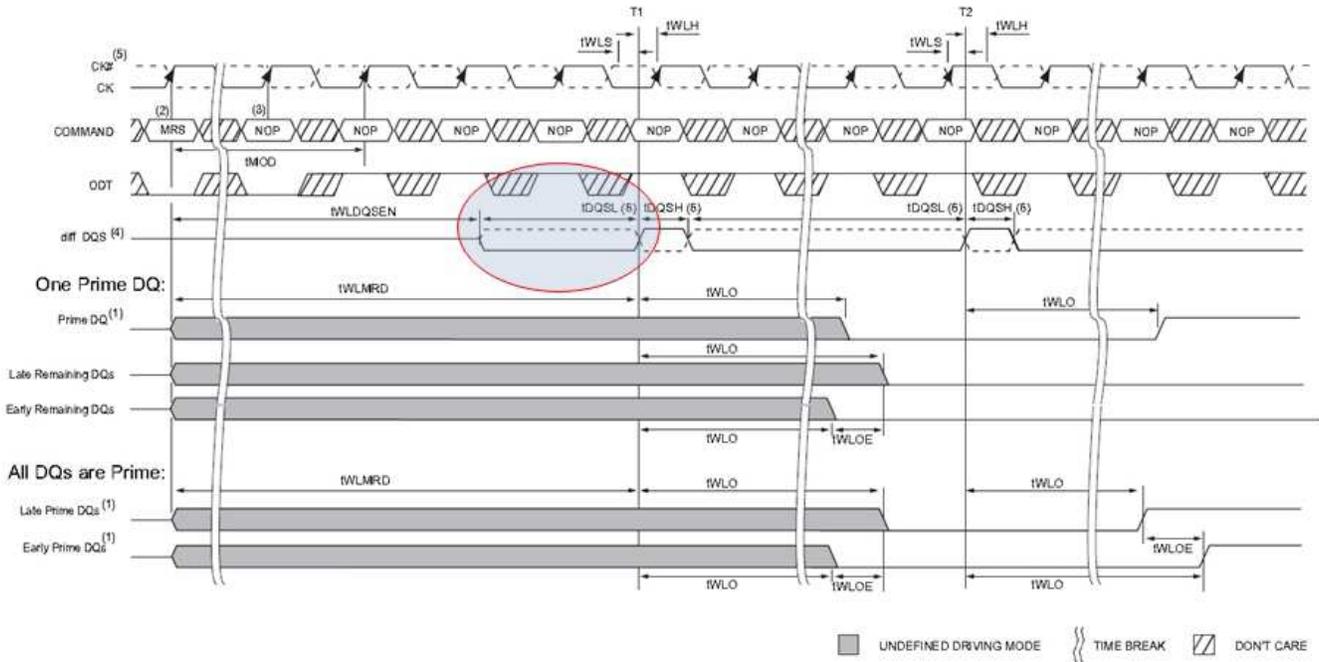
**Figure 9. Timing Details of Writing Leveling Sequence**

As shown in Figure 9, the DDR3 JEDEC standard requires that the DQS strobe be sent with a preamble (DQS=0) for at least tDQSL during write leveling, prior to the first rising edge of the DQS strobe (DQS=1). It was observed in simulations that the first DQS strobe is sent immediately following the high impedance state of the DQS line and without a preamble. This Z->1 transition on the DQS line may allow incremental write leveling to fail. Note that this issue impacts only the incremental write leveling feature of the DDR3 Memory controller. No issue is expected with automatic write leveling.

At this time, incremental write leveling is not supported on this device and we recommend that the incremental write leveling intervals in RDWR\_LVL\_CTRL and RDWR\_LVL\_RMP\_CTRL be programmed to 0 to disable this feature.

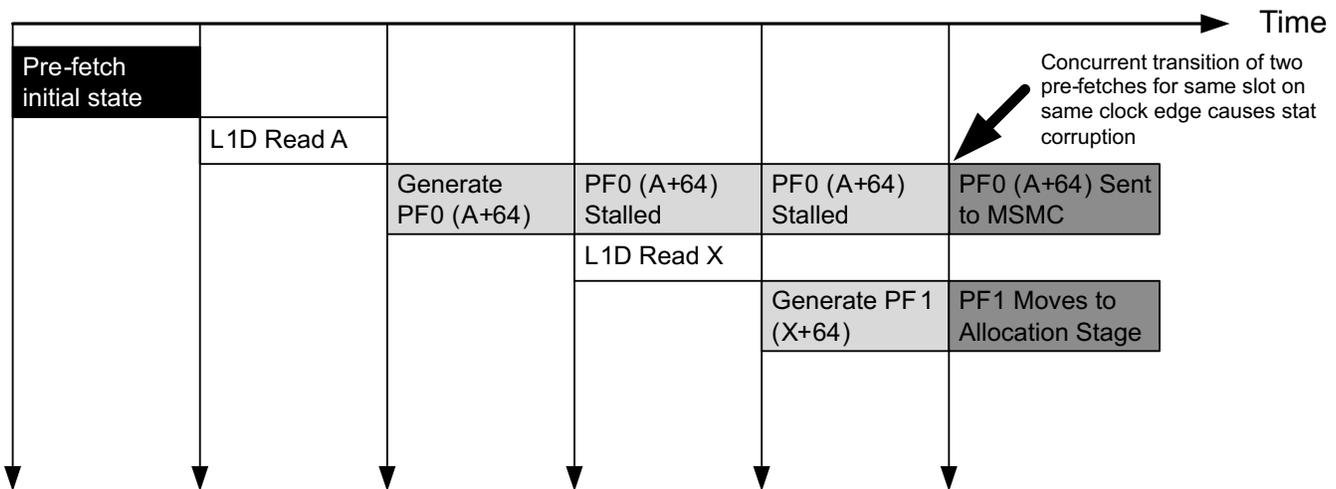
Figure 11. Sequence diagram

6. A pre-fetch for address X+64 (PF1) is generated for entry [0] early half and followed in a subsequent cycle by X+128 (PF2).
  - (a) Either PF1 or PF2 can map to the same buffer slot as PF0 (this example maps PF1)

7. PF0 transitions to the XMC output (to MSMC) on the exact same clock edge that PF1 is transitioning to the buffer allocation pipeline stage

8. Instead of PF0 being marked stale and thrown away when returned, both PF0 and PF1 are marked valid and outstanding.
9. This leads to two valid outstanding pre-fetches for the same data buffer slot which is an invalid state and can result in unexpected behavior for a subsequent pre-fetchable data access to address X+64.
