TMS320F2807x MCUs Silicon Revisions C, B

This document describes the silicon updates to the functional specifications for the TMS320F2807x microcontrollers (MCUs).

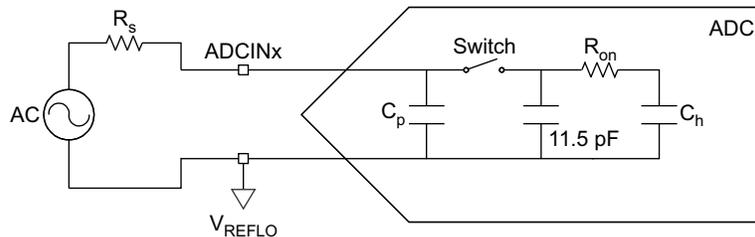
Figure 3. Single-Ended Input Model

Details The ADC input model should be used to select the sample-and-hold (S+H) duration for each ADC input. For the revisions affected, if the currently converting channel is an even-numbered channel and the previously converted channel was an odd-numbered channel (or vice versa), then the 12-bit input model will not accurately predict ADC input performance. Under these conditions, an additional capacitance should be added to the model. This capacitance has a value of 11.5 pF and should be placed between the S+H switch and R_{on} as shown in [Figure 3](#).

Workaround(s) For the revisions affected, when subsequent conversions switch between channel groups, the S+H duration should be chosen to account for the additional capacitance.

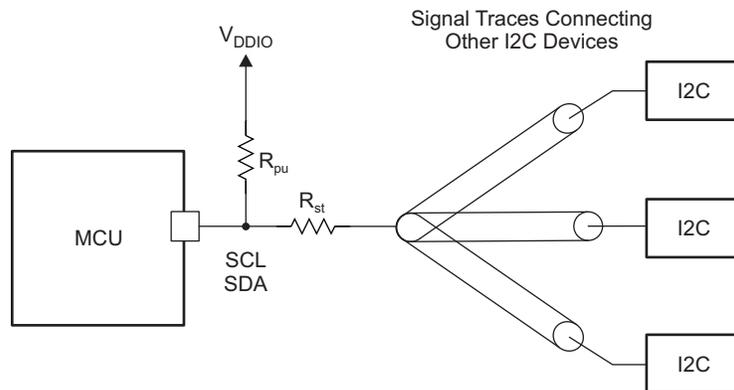
Figure 7. Placement of Series Termination Resistor and Pullup Resistor

The SDA and SCL outputs are implemented with push-pull 3-state output buffers rather than open-drain output buffers as required by I2C. While it is possible for the push-pull 3-state output buffers to behave as open-drain outputs, an internal timing skew issue causes the outputs to drive a logic-high for a duration of 0–5 ns before the outputs are disabled. The unexpected high-level pulse will only occur when the SCL or SDA outputs transition from a driven low state to a high-impedance state and there is sufficient internal timing skew on the respective I2C output.

This short high-level pulse injects energy in the I2C signals traces, which causes the I2C signals to sustain a period of ringing as a result of multiple transmission line reflections. This ringing should not cause an issue on the SDA signal because it only occurs at times when SDA is expected to be changing logic levels and the ringing will have time to damp before data is latched by the receiving device. The ringing may have enough amplitude to cross the SCL input buffer switching threshold several times during the first few nanoseconds of this ringing period, which may cause clock glitches. This ringing should not cause a problem if the amplitude is damped within the first 50 ns because I2C devices are required to filter their SCL inputs to remove clock glitches. Therefore, it is important to design the PCB signal traces to limit the duration of the ringing to less than 50 ns. One possible solution is to insert series termination resistors near the SCL and SDA terminals to attenuate transmission line reflections.

Insert series termination resistors on the SCL and SDA signals and locate them near the SCL and SDA terminals. The SCL and SDA pullup resistors should also be located near the SCL and SDA terminals. The placement of the series termination resistor and pullup resistor should be connected as shown in [Figure 7](#).

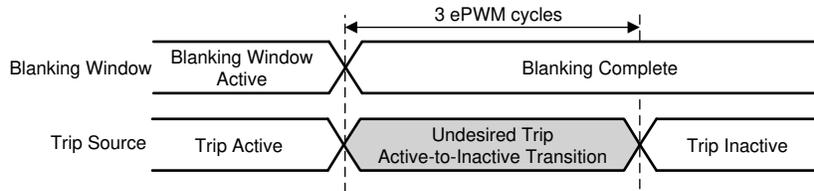
Figure 8. Undesired Trip Event and Blanking Window Expiration

Details The blanking window is typically used to mask any PWM trip events during transitions which would be false trips to the system. If an ePWM trip event remains active for less than three ePWM clocks after the end of the blanking window cycles, there can be an undesired glitch at the ePWM output.

Figure 8 illustrates the time period which could result in an undesired ePWM output.
