TMS320DM365
Digital Media System-on-Chip (DMSoC)
Silicon Revision 1.1 and 1.2

Silicon Errata

Literature Number: SPRZ294E
March 2009–Revised July 2011

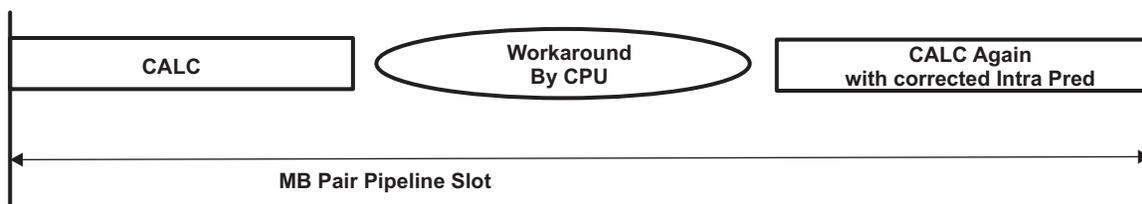
Figure 3. MB Pair Pipeline Slot Example

Advisory 1.2.3 HDVICP—H.264 Encode/Decode: Intra 16 x 16 Plane MB Values \geq 512 are Incorrect
Revision(s) Affected: 1.2 and earlier

Details: During the calculation of the intra prediction block, pixel values can reach 512 or higher. However, the computation engine has precision only enough to hold values equal to 511 or less.

During a MB pipeline slot, a CALC is done, a workaround by CPU, and CALC again with corrected intra prediction macroblock (see [Figure 3](#)).

If the MB is of intra 16x16 plane mode, perform the following steps:

1. Let CALC run.
2. Wait for CALC to complete
3. After CALC completes, switch BFSW for iprdbuf : CALC → DMA
4. Check and correct Intra Prediction (for more details, see the *Check and Correct Intra Prediction* section below)
5. Switch BFSW for iprdbuf : DMA → CALC
6. Switch BFSW for calcmbuf : CALC → DMA
7. Set up CALC commands with intra mode for IQ/IT and inter mode for prediction (for more details, see the *Set up CALC Commands with Intra mode for IQ/IT and Inter Mode for Prediction* section below)
8. If MBAFF, retrigger DMA for upper row data
9. Switch BFSW for calcmbuf : DMA → CALC
10. Switch BFSW for reconbuf : LPF → DMA
11. Read left reconstructed column
12. Switch BFSW for reconbuf : DMA → LPF
13. Switch BFSW for calcsbuf : CALC → DMA
14. Set back left reconstructed column
15. Switch BFSW for calcsbuf : DMA → CALC
16. Re-run CALC
17. Wait for CALC to complete
