MSP430FG4616 Device Erratasheet

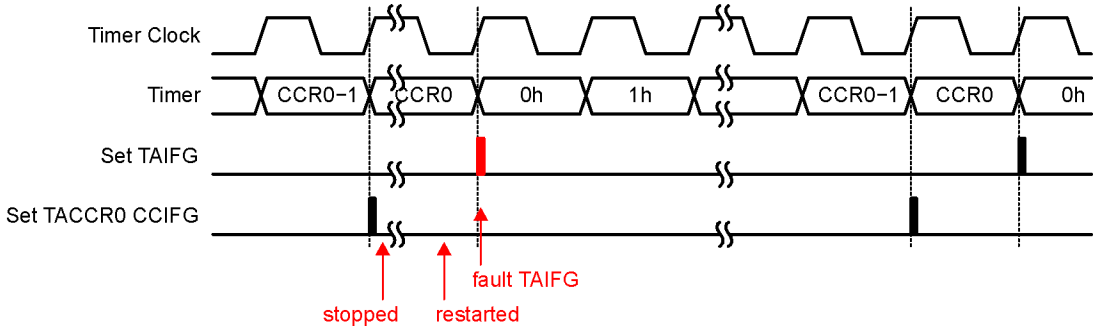
TA21 *TIMER_A Module*

Function TAIFG Flag is erroneously set after Timer A restarts in Up Mode

Description In Up Mode, the TAIFG flag should only be set when the timer counts from TACCR0 to zero. However, if the Timer A is stopped at TAR = TACCR0, then cleared (TAR=0) by setting the TACLR bit, and finally restarted in Up Mode, the next rising edge of the TACLK will erroneously set the TAIFG flag.

Workaround None.

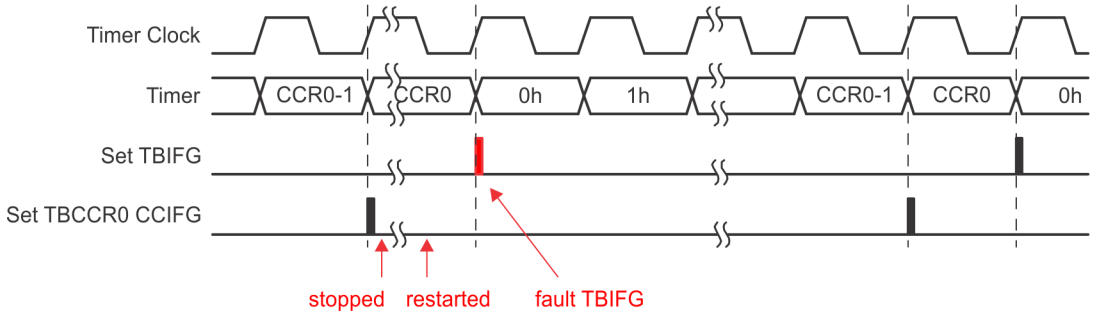
TB24 *TIMER_B Module*

Function TBIFG Flag is erroneously set after Timer B restarts in Up Mode

Description In Up Mode, the TBIFG flag should only be set when the timer resets from TBCCR0 to zero. However, if the Timer B is stopped at TBR = TBCCR0, then cleared (TBR=0) by setting the TBCLR bit, and finally restarted in Up Mode, the next rising edge of the TBCLK will erroneously set the TBIFG flag.

Workaround None.
