AM1806 ARM Microprocessor Silicon Revisions 2.3, 2.1 and 2.0

Silicon Errata

Literature Number: SPRZ314H
March 2010–Revised September 2014

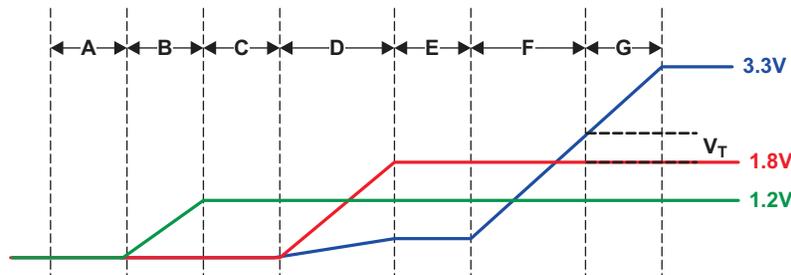
Figure 3. Normal power-supply ramp

Important Note: The 3.3V DVDD3318_x supplies must not be driven to 0V during zones A – E or high current capable of damaging the device may occur. The 3.3V DVDD3318_x supplies should not be driven during this time.

- A. All device supplies are undriven
- B. The 1.2V supplies are ramped to their nominal levels
- C. Potential delay between supply ramps (not required)
- D. The 1.8V supplies (specifically DVDD18) are ramped to their nominal levels. During the DVDD18 ramp there will be some minor drift up in the undriven DVDD3318_x supplies. This is normal and is not a problem.
- E. Potential delay between supply ramps (not required)
- F. DVDD3318_x is ramping but is less than DVDD18 + V_T
- G. DVDD3318_x is ramping but is greater than DVDD18 + V_T

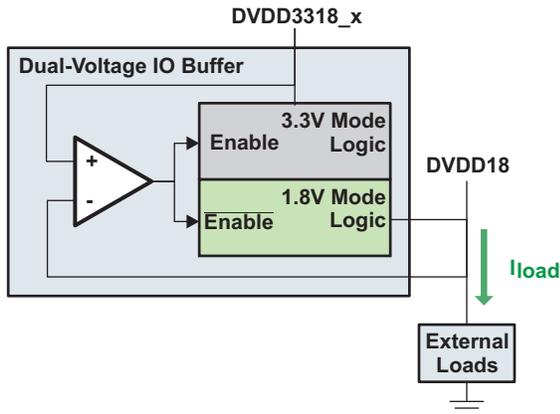
The condition occurs because the dual-voltage IO buffers have voltage detection circuitry that monitors DVDD3318_x during reset and determines whether the applied supply voltage is 1.8V or 3.3V. This detection circuitry then configures the IOs to operate at the appropriate voltage. As the DVDD3318_x supply ramps, there is a small range near DVDD18 + V_T where the voltage detection circuit finds the state indeterminate and briefly turns on circuitry associated with both voltage options creating a current path between them. This current path can cause the DVDD18 supply to be pulled up. The mechanism for this behavior is explained below:

Behavior of the IO buffer during Zone F:

As the DVDD3318_x supply ramps, but is not yet one V_T above the DVDD18 supply, the comparator enables the 1.8V mode logic section and disables the 3.3V mode logic section. No unexpected current flows between the two sections.

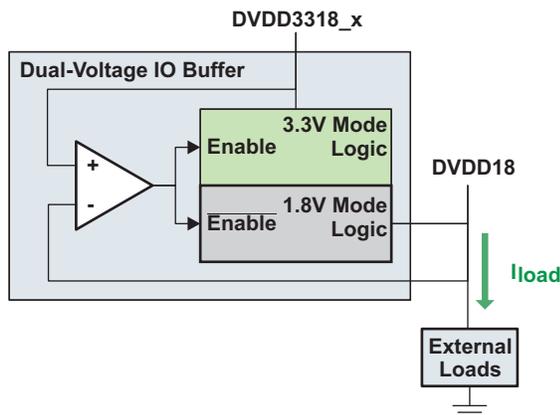
Figure 6. Error State of the IO buffer during Zone G

If DVDD18 continues to rise as DVDD3318_x ramps, the comparator never sees enough difference between the two supplies to switch to 3.3V mode.

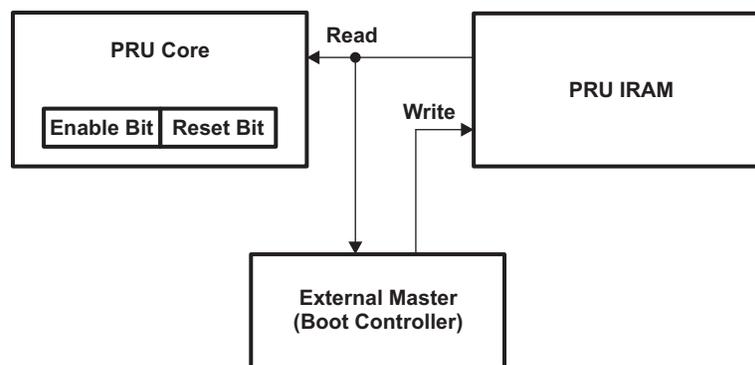
Figure 8. PRU and Boot Controller Block Diagram

The ARM reset vector table is located in the ARM's local RAM, however the ARM local RAM can only be accessed by two bus masters: ARM and PRU0. Therefore, the Boot Controller must program PRU0 to copy the desired reset vector table into the ARM's local RAM.

The PRU instructions are located inside of an instruction RAM (IRAM) which is initialized by the Boot Controller (see Figure 8). After the instructions are stored to IRAM, the PRU is reset and enabled to execute its instructions. In this case, the PRU is instructed to initialize the ARM reset vector table.

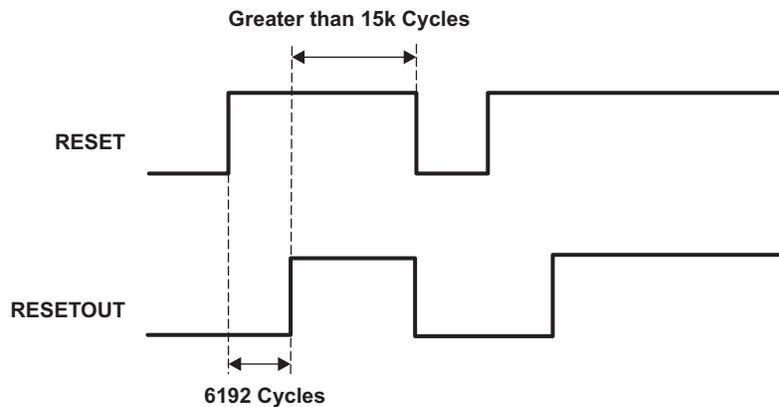
Figure 11. First POR Reset Timing

Note that in order to recover from this fail state with a secondary reset, the Boot Controller must be allowed to execute up to the point where the PRU has fetched a known instruction from the PRU IRAM. The approximate count of 15k clock cycles is sufficient.

The 15k clock cycle count does not include the 6192 clock cycles required to complete a device POR reset (see Figure 11). With a 24MHz crystal, the first RESET signal must be asserted high for at least 883us (or approximately 1ms).

Modify the target board so that the affected device is given a secondary reset on power-up as shown in Figure 11. Two example methods are described in the sections that follow.

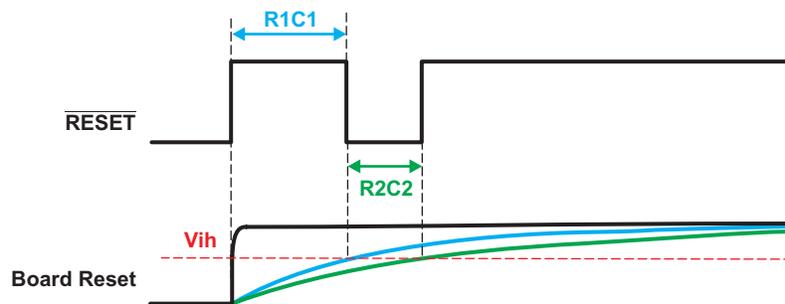
Figure 14. RESET Signal vs Board Reset

This is possible because each RC load connected to the board reset control signal can output a different rising-edge waveform. With increasing RC load, the resulting control signal will reach the Schmitt buffers' V_{ih} level at a later point in time.

Figure 14 shows the relationship between the board reset signal and the RESET signal produced by the circuit. The blue and green lines represent the voltage as seen by the Schmitt buffers. The output voltage of a charging RC circuit is defined as: $V_o = V_i * (1 - e^{-t / RC})$

Given ideal conditions, a 3.3V board reset signal, and an input buffer V_{ih} of 1.4V, the following set of component values would generate an initial RESET high period (R1C1 region) of approximately 2ms and a RESET low period (R2C2 region) of approximately 0.5ms:
