**TMS320C6672**  
**Multicore Fixed and Floating-Point Digital**  
**Signal Processor**  
**Silicon Revision 1.0, 2.0**

**Silicon Errata**

Literature Number: SPRZ335H  
January 2011–Revised June 2015

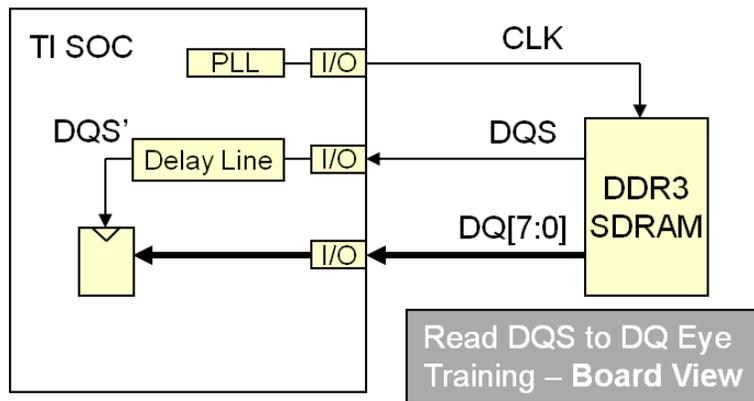
**Figure 2. Read DQS to DQ Eye Training - Board View**

The leveling feature with the problem is the Read Data Eye Training. Depending on the jitter seen on the DQ and DQS signals, this leveling feature will fail to converge on a good data eye, resulting in corrupted DSP to DDR3 SDRAM reads.

The intended purpose of the Read Data Eye Training feature is to align the DQS sampling transitions in the middle of the DQ data eye within individual byte lanes of the DDR3 memory interface. As seen in Figure 2, the DQS signal can be delayed relative to the DQ signal within the DDR3 PHY.

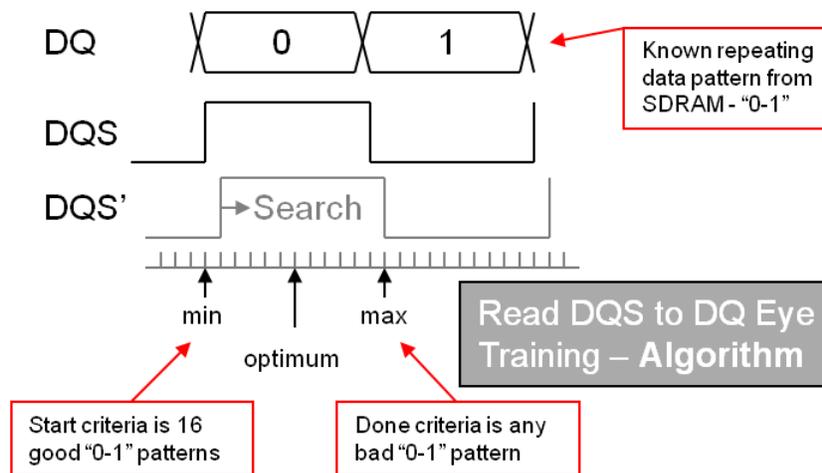
**Figure 3. Read DQS to DQ Eye Training - Algorithm**

As shown in Figure 3, the Read Data Eye Training algorithm should correctly detect the extents of the DQ data eye. The SDRAM are put into a DQS to DQ eye training mode and read back an alternating 0, 1 pattern.

The DDR3 PHY uses this pattern to detect good or bad data being sampled by the DQS transitions. The DDR3 PHY searches by delaying DQS relative to DQ until these constraints are found.

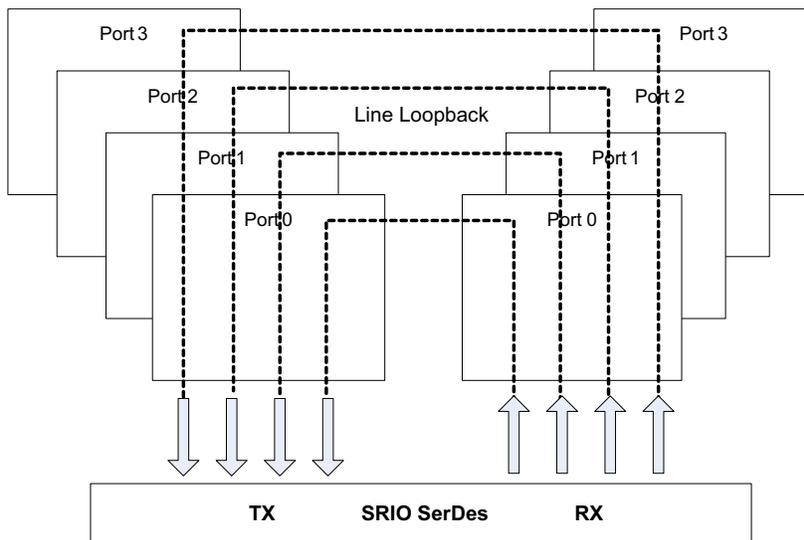
**Figure 5. SRIO SerDes in Loopback Mode**

The SRIO physical layer is configured in line loopback mode on a per-port basis, by setting the LLB\_EN bit in PLM\_SP(n)\_IMP\_SPEC\_CTL register. In line-loopback mode, the data from the SerDes receiver is looped back to the SerDes transmitter. [Figure 5](#) shows the line loopback from SerDes RX to SerDes TX:

The port does not provide any clock compensation when line loopback is enabled. The transmit clock must be externally synchronized with the receive clock. There is only a small FIFO that can compensate for PLL jitter or wander. Hence, correct operation of line loopback requires that the link partners use the same reference clock for the SRIO physical layer, in order to avoid overruns or underruns due to clock frequency mismatch between the link partners. As a result, line loopback mode is generally restricted to validation and qualification of board signal integrity in a lab environment.
