Intel® Xeon® Processor 5600 Series

Specification Update

February 2015

Reference Number: 323372-017US

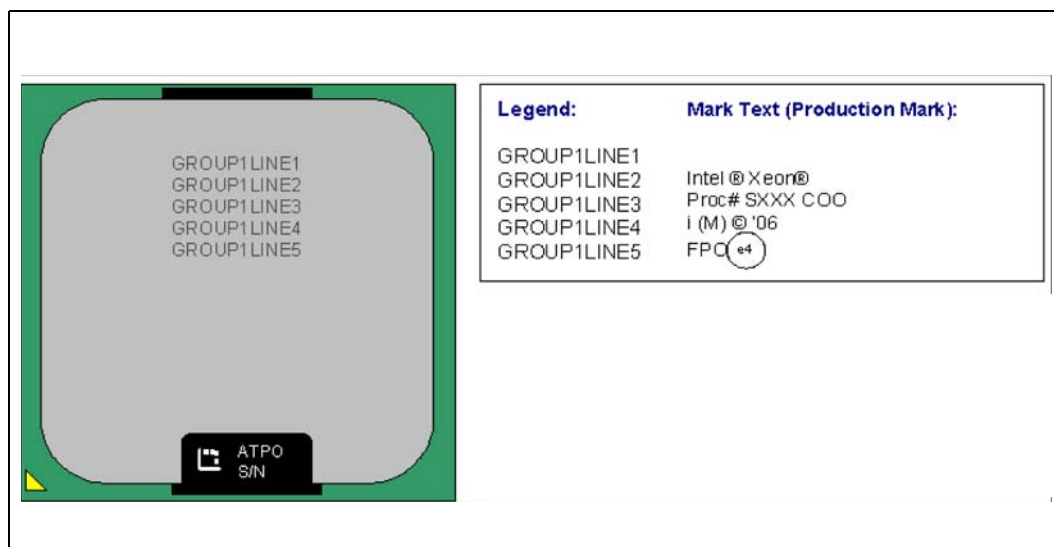
Figure 1. Processor Top-side Markings (Example)

The Intel® Xeon® Processor 5600 Series can be identified by the following component markings:
